# Investigation of the Greenhouses in Istanbul in Terms of Structural Properties

Hacer Şakar Kolay<sup>1</sup>, Can Burak Şişman<sup>2</sup>

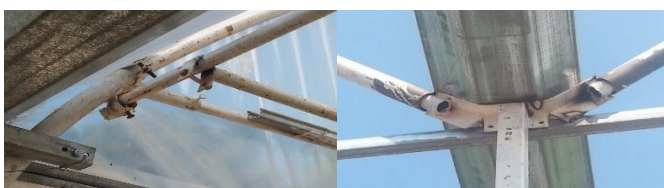
In the joining types of metal elements, welding ranks first by 60%, mixed (welding + screw) ranks second by 26.6%, and bolt ranks third by 13.2% (Figure 1). Welded connection is mostly preferred by producers due to its robustness. However, it is necessary to clean the burrs formed on joints well in order to avoid damages to the cover, especially in plastic-covered greenhouses [8] (Yüksel, 2000).

Figure 1. Joining type of metal elements (screw, welding)

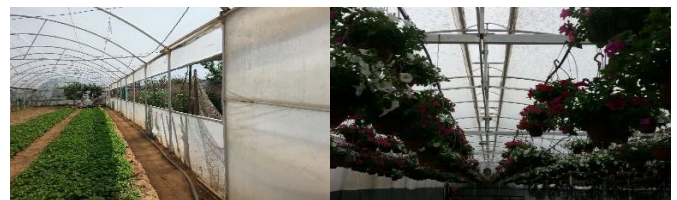
Natural ventilation is performed in all of the greenhouses and high tunnels where the study was carried out. Ventilation is usually performed by opening the cover material on the side wall. 6% of the greenhouses have roof ventilation windows (Figure 2). The ratio of the roof window area to the greenhouse floor area of these greenhouses is 5.64%. While it is desired that roof ventilation is as large as 20% of the greenhouse floor area for good greenhouse ventilation, this ratio varies between 1 and 4% in greenhouses in our country [5] [12] (Sevgican, 1999; Gezer et al., 2009). In the light of the obtained data, it can be said that although the roof ventilation window areas in the greenhouses in the region are above the country's average, they are very inadequate.

Figure 2. Ventilation on wall and roof in the greenhouses

In natural ventilation systems, ventilation is performed through windows in greenhouse side walls and roofs. For good ventilation, the total window area of the greenhouse must be between 16-25% of the greenhouse floor area. Windows that are effective in ventilation are roof windows. Although 6% of the greenhouses in the research area have roof ventilation windows, their sizes are very inadequate. Moreover, the vast majority of the greenhouses and high tunnels examined do not have side and roof ventilation windows. This determined situation has revealed that effective ventilation cannot be performed in the entire research area. Accordingly, water condensing on the inner surface of the cover material falls on plants and causes various fungal diseases. Furthermore, the condensed water causes wood decay and oxidation of metals in bearing materials.
