Settlement Monitoring of Embankment Dams: Case Study of Gurara Dam, North Central Nigeria

Osuagwu J. C.¹, Owakah A.², Chukwuocha A. C.³, Ibeje A. O.⁴

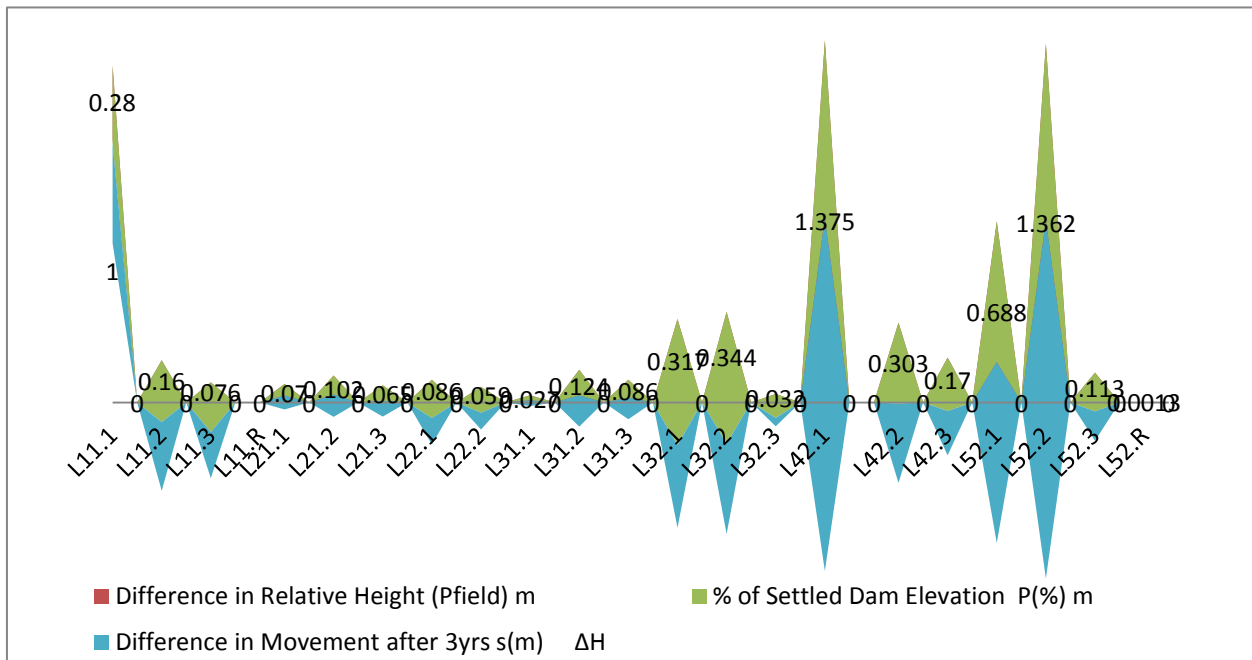
Figure 4. Percentage of Settled Levels

The computations were repeated for the other sections and the results are plotted in Figs 4 and 5. The results show that the value of P% (Percentage of total elevation that settled in all the sections of the embankment) is less than 1%. Also the value of S_i (Settlement index) in all the sections of the embankment is far less than 0.02.

- i. The value of P% (Percentage of total elevation that settled in all the sections of the embankment) is less than 1% meaning that the post construction settlement of the embankment is very much within the standard.
- ii. The value of S_1 (Settlement index) in all the sections of the embankment is far less than 0.02. This indicates absence of creep or secondary consolidation of the embankment material.
- iii. Values obtained from settlement calculations at all sections of the dam embankment are very negligible indicating that there have been no unsafe developments on the embankment.
- iv. It is also evident based on the various graphs plotted that the Gurara dam embankment is performing as expected according to the design and construction.

- i. There should be timely and adequate maintenance of the dam embankment instrumentations particularly DSM instrumentations at the dam site.
- ii. Periodic settlement studies should be carried out to ascertain the condition and level of safety of the dam. The studies should be extended to foundation settlements.
