Analysis of the Degree of Deterioration of Concrete Posts Utilized by the Electrical Transmission and Distribution System

Keywords- Poles, Pathological Manifestations, Inspections

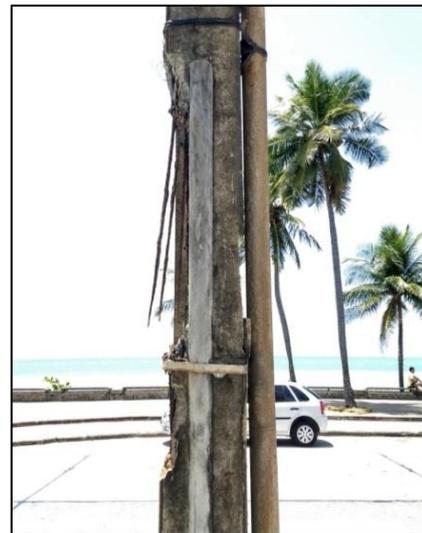
In (Figure 2) shows a T-type post in which the main frame has been ruptured as a consequence of corrosion caused by pathological manifestations, having an element damage degree of 121.00, indicating that immediate intervention is required. The damages with the highest indices are "stains" and "cracks", "disintegration", "reinforcement corrosion", and "concrete failure".

Figure 2. Post with broken reinforcement.

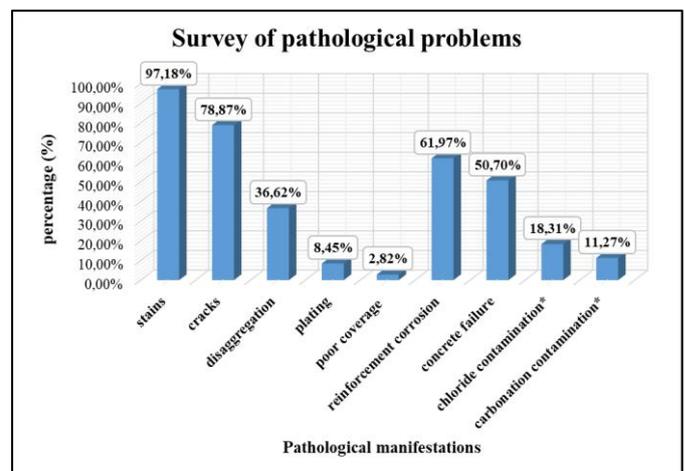
All poles, whether of new or old manufacture, have stains on their surfaces of more or less intensity. These surface stains are due to the humid environment, the highly-polluted atmosphere, and biological agents. In (Figure 3), the percentages for each pathological manifestation found during the performed inspections is shown. "disintegration", "reinforcement corrosion", and "concrete failure".

Figure 3. Rate of pathological manifestation incidence in concrete posts.

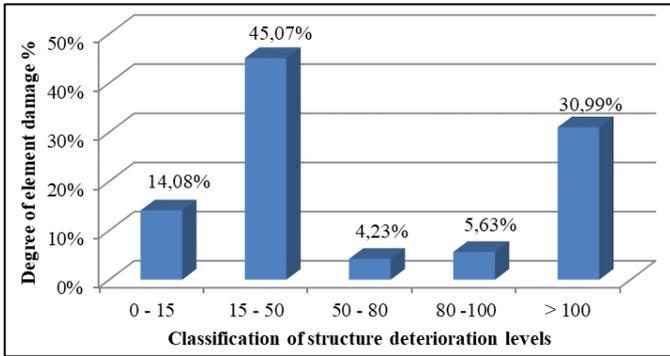
The degree of element degradation, shown in (Figure 4), was alarming in terms of the level classification, because 4.23%, 5.63%, and 30.99% will require interventions within one year, six months, or immediately. The posts that fall within the 15-50 classification represent 45.07% of the total and are continuously exposed to the aggressive environment.

Figure 4. Degree of deterioration of elements classification of the levels of structural deterioration.

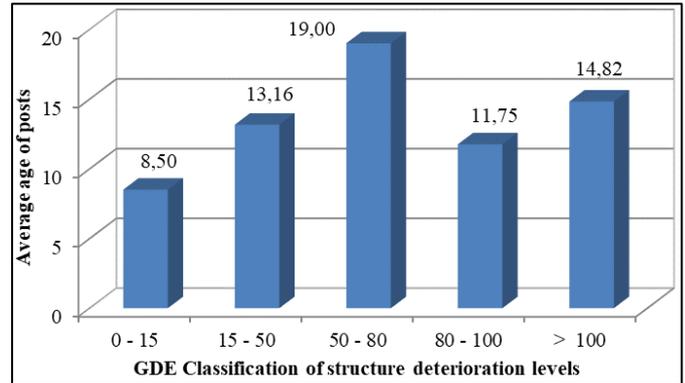
The average age of 19 years, shown in (Figure 5), for posts having a degree of element deterioration (GDE) between 50 and 80, according to the Castro [3] GDE/UnB methodology, modified by Fonseca [1], require detailed specialized inspection to define a plan for medium-term intervention (up to one year).

Figure 5. Average age of posts in the degree of element deterioration classification intervals.

Posts having GDE between 80 and 100 require intervention within six months, while those with GDE greater than 100 will need immediate intervention to halt the worsening of their current structural situation.

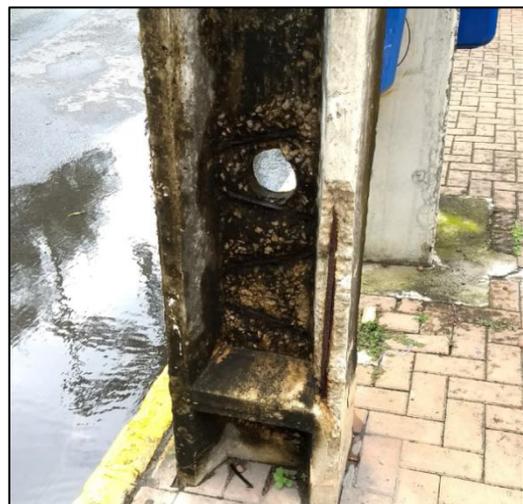
The pole shown in (Figure 6) is 23 years old and has not reached the limit of its design life, but it already shows signs of reinforcement corrosion with a high level of concrete deterioration.

Figure 6. Corrosion of reinforcement with loss of concrete section.
