Nano Coating Application for Corrosion Reduction in Oil and Gas Transmission Pipe: A Case Study in South of Iran

E. Noveiri¹, S. Torfi²

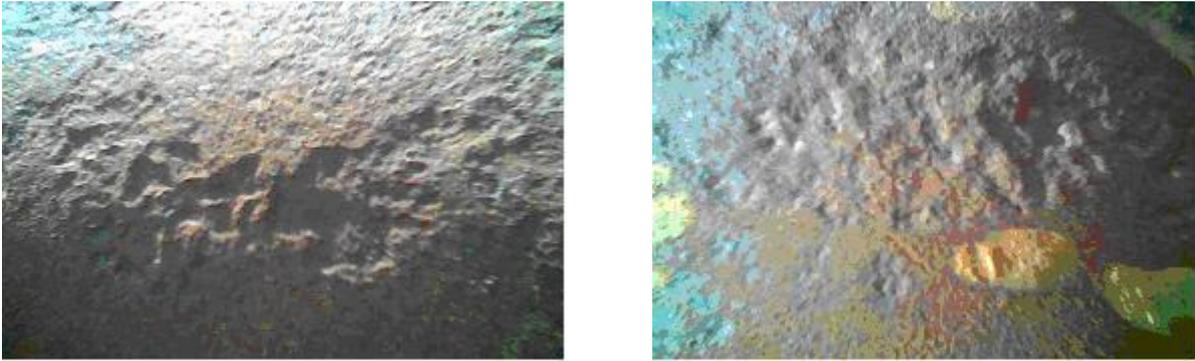
Figure 1, 2- corrosion under insulation in maroon desalting plants

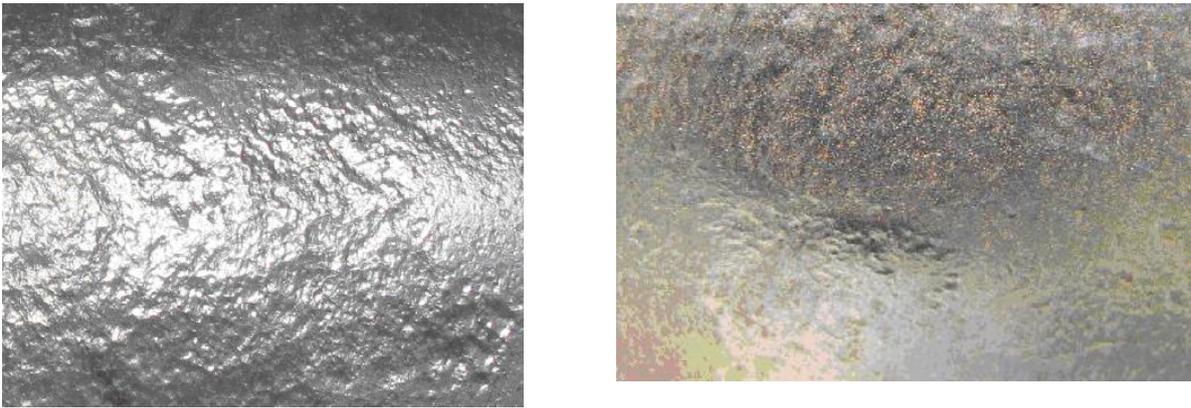
Figure 3, 4 - initially a layer of coating with a thickness of 30 microns was placed on surface of a piece of pipe with referred standard. Left figure two layers of 30 microns (thickness 60 microns) were placed on the surface.

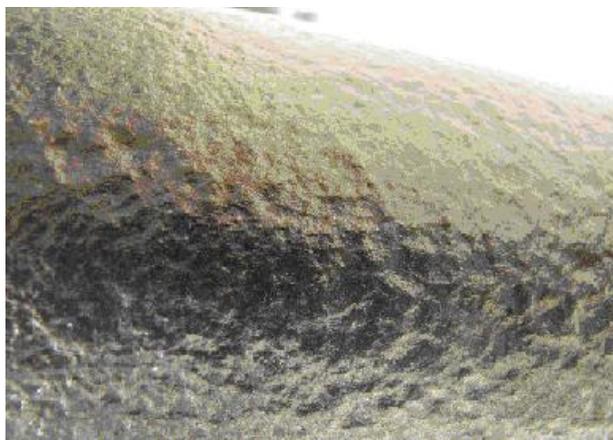
Figure 5- third stage, two layers of 60 microns (140 microns)

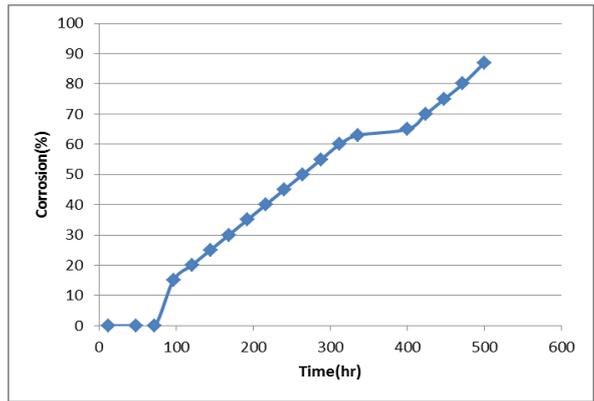
Diagram 1- First case coating of 30 microns thickness

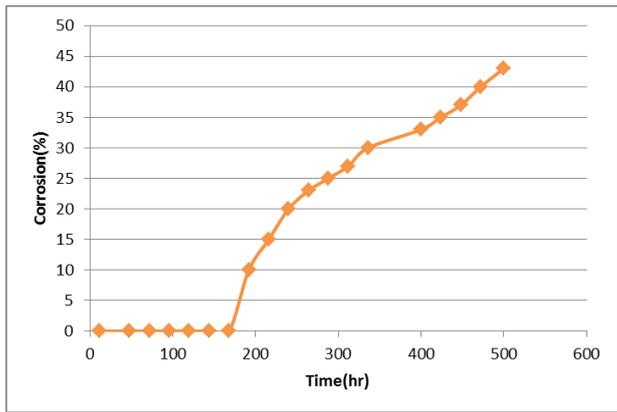
Diagram 2- second case coating of 60 microns thickness

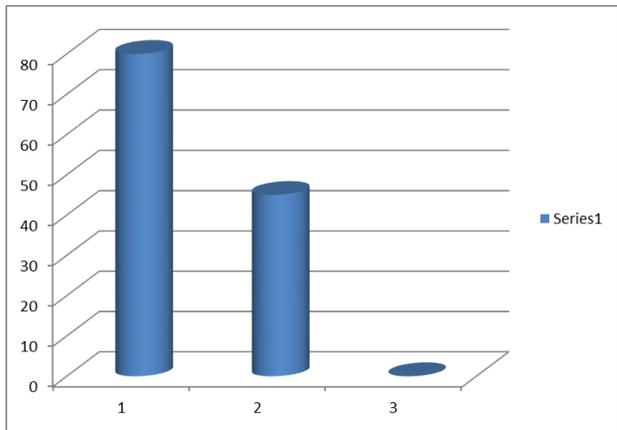
Diagram 3-Comparison of three coatings model

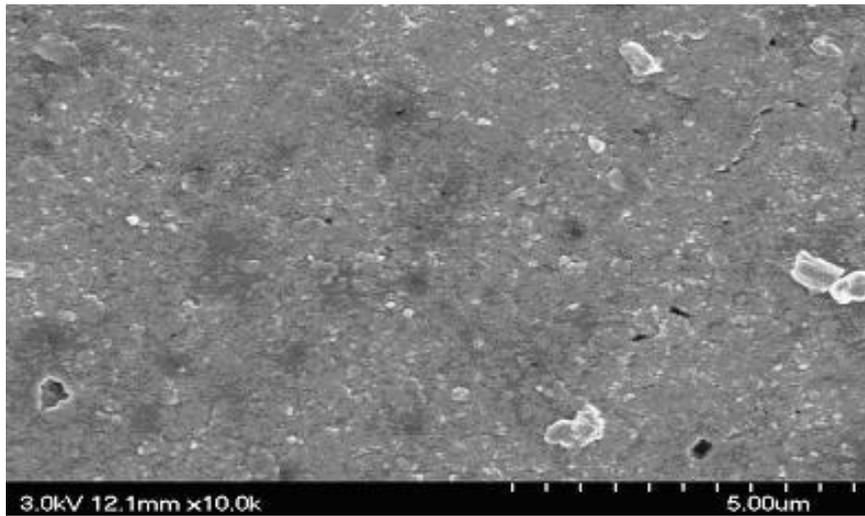
Figure 6- electron microscopy images (SEM) third mode of approximately 140 microns

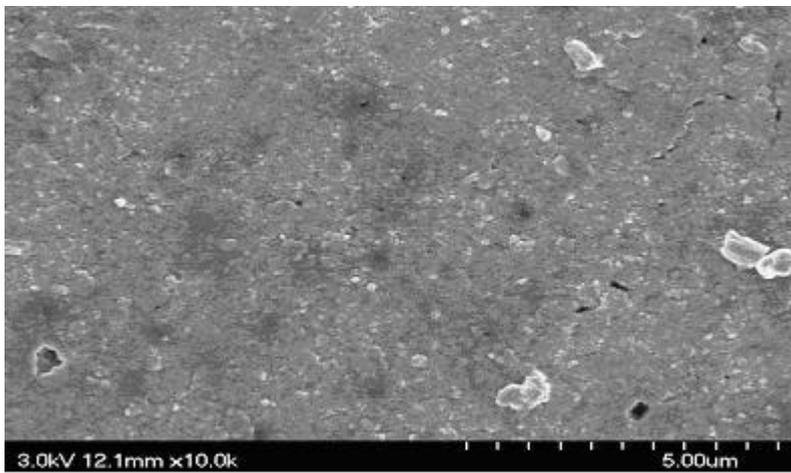
Figure 7, 8- electron microscopy images (SEM) of second case 60 thickness (right) and without coating (left).
