Slope Stability Analysis of Embankment of Jamuna River

Abstract- This research paper deals with analysis of the stability of an embankment which has been carried out considering different slopes. This study was performed with a view to running several simulations and to analyze those to know the pattern of slope failure for certain field conditions. For this purpose embankment soil has been collected from Benotia in Sirajganj near the bank of the river Jamuna. Field bore-logs has been done up to a depth of 30m. The soil was collected in conventional method and brought to Geotechnical Engineering Laboratory of Bangladesh University of Engineering & Technology (BUET) for several tests. These tests were performed in accordance with American Society for Testing and Materials (ASTM). The test results exhibited the soil properties necessary for this analytical study.

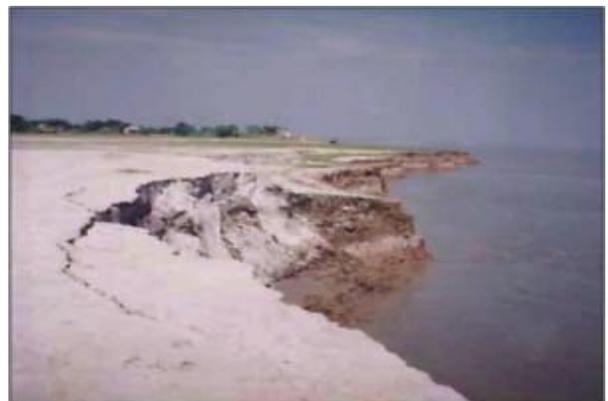
Fig. 1: Jamuna river bank before construction of any bank protection structure [2].

The 2900 km long river Jamuna originating from Himalayas has 240 km inside Bangladesh. This mighty river tends to change its course very frequently and is prone to erosion and widening of the bank. From 1970 to 1990 the Jamuna River widened a very high rate of migration where both banks migrated outward at an average rate of about 70 meter/year. Since the early 1990s, the rate of outward migration of both banks has reduced to 30-50 meter/year [1]. Every year this river undergoes huge river erosion as well as great damage of property and livelihood. Bangladesh Govt. has taken few steps including constructing revetments to prevent the change of direction of this mandarin river but from time to time the soil under the concrete blocks of revetment got washed away due to strong current and other natural reasons causing ultimate revetment failure. To protect bank erosion, more than thirty bank protection structures have been constructed along both banks of the Jamuna River. Almost every year a number of structures encounter different types of failure problems and maintenance of such failure or damaged events are one of the big challenges to Bangladesh Water Development Board (BWDB). This case study was performed on the soil of failed embankment of river Jamuna. Fig.1&2 shows the conditions of the river before and after construction of bank protection structures.

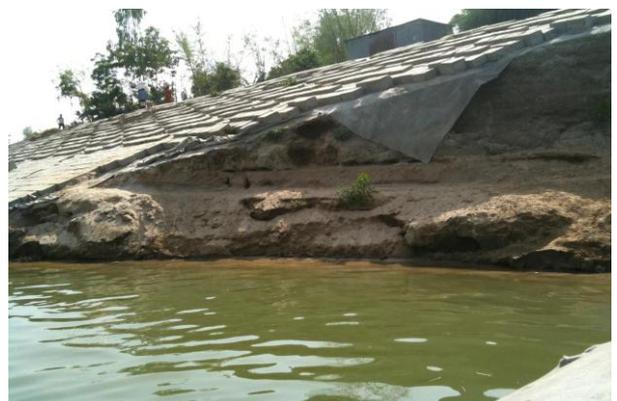
Fig. 2: Jamuna river bank after failure of a bank protection structure.

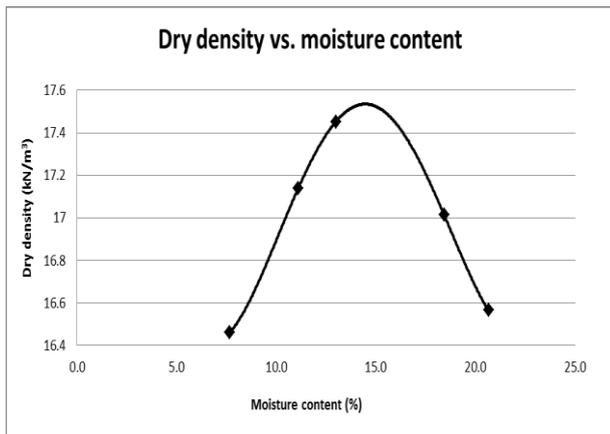
Fig. 3: Dry density vs. Moisture content curve.

This curve shows the interrelation of the sample’s dry density with the existing moisture content. This curve was generated from test result and the peak dry density was considered to be 17.5kN/m^3 (Fig. 3).

Having identified the type of soil dry density test was performed with several moisture contents and the data was plotted to generate dry density vs. moisture content curve.

From the curve the maximum dry density was found 17.5kN/m^3 and respective moisture content was found 15%.

The 95% of maximum dry density (95% of 17.5 is 16.5) was taken for making samples for further compaction test. The value is taken from the west side of the curve. MC for density 16.5kN/m^3 is 20%.

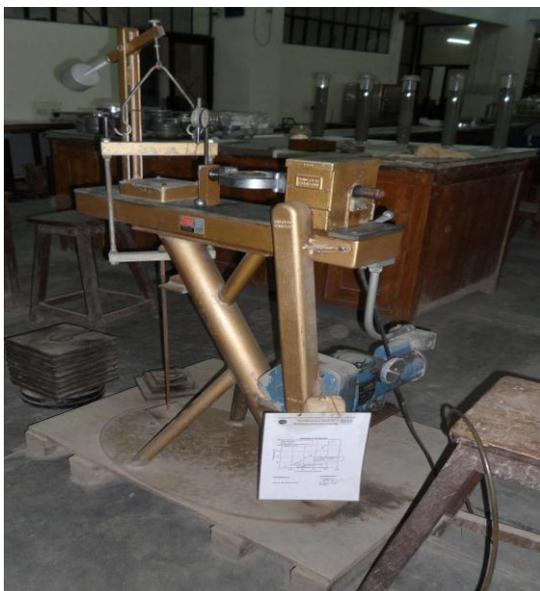
Fig. 4: Laboratory preparation for direct shear test.

Molds were prepared using 20% moisture content for direct shear test. The shear test was performed under consolidated undrained condition. Three different Shear stress vs Shear displacement curves were obtained for 8kg, 16kg & 32kg normal loads (Fig. 5). Laboratory preparation for direct shear test is shown in Fig. 4.

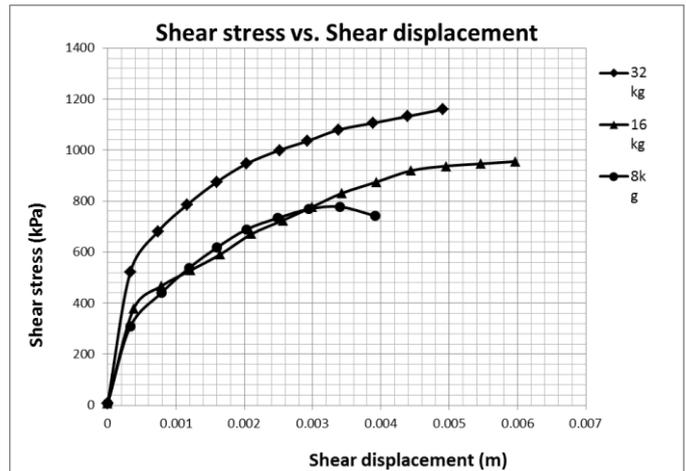
Fig. 5: Shear stress vs Shear displacement curve for 3 different lodes (32kg, 16kg & 8kg).

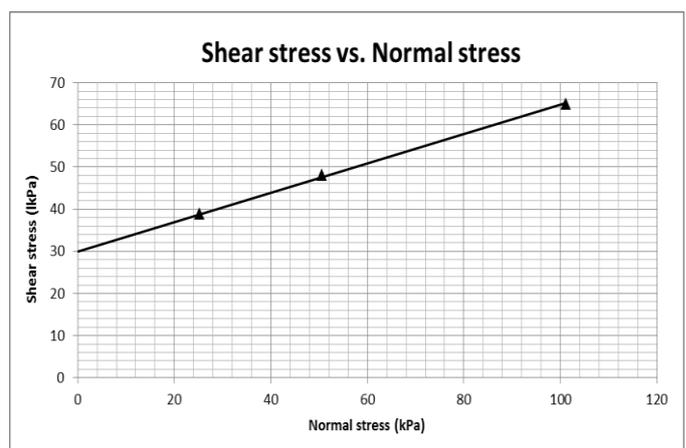
Fig. 6: Shear stress vs Normal stress curve.

Shear stress vs. normal stress curve (Fig. 6) was generated from the Shear stress vs. Shear displacement curve.

From the Shear stress vs. normal stress the value of cohesion ‘C’ and friction angle Φ were obtained ($C = 30\text{kPa}$, $\Phi = 34^\circ$). These values show the main properties of the collected soil sample.

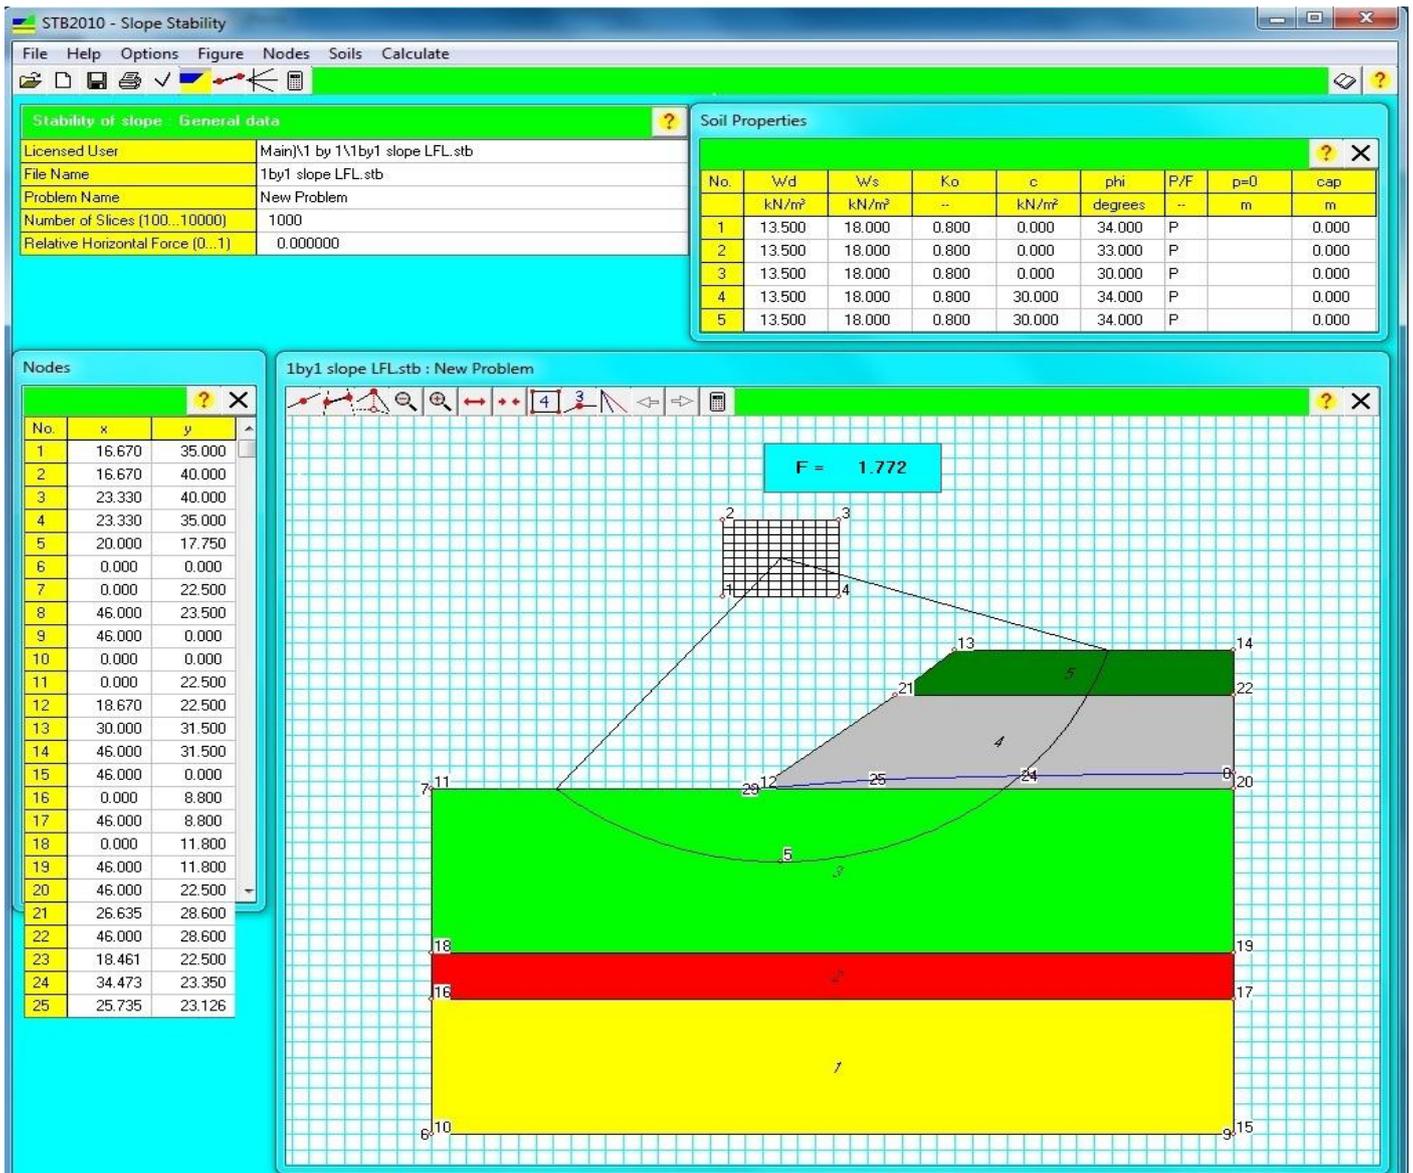
Fig. 7: Slope stability analysis with 1:1 slope for a soil of (C = 30 kPa, $\Phi=34^\circ$) in Low water level condition.

sand volumetrically. These two new samples were made to observe the simulations repeatedly. The whole procedure was repeated for two more times and the simulations from STB2010 were obtained. The results projected corresponding factors of safety making a total of 27 conditions. Among these conditions including the two new samples, all of the factors of safety are presented in tabular form for further observations and analysis. Due to shortage of space screenshot from only one calculation by STB2010 is presented (fig. 7).
