Failure Analysis of a Natural Gas Pipeline-Case Study

Abstract- This paper discusses the failure of a natural gas pipeline due to stress corrosion cracking (SCC). It was diagnosed that the SSC was magnified by coating disbondment. High-density polyethylene coatings are vulnerable to disbonding. Disbonding can be initiated by either cathodic protection systems and osmotic conditions or a combination of these. External soil stress accompanied by the diffusion of moisture, oxygen, and carbon dioxide under the pipeline coating created a corrosive environment, initiating cracks into the pipe structure. The paper addresses how altering cathodic protection criteria, repairing coatings on weld joints or the welds themselves, and using coatings less sensitive to disbonding can reduce stress corrosion cracking-induced pipeline failures.

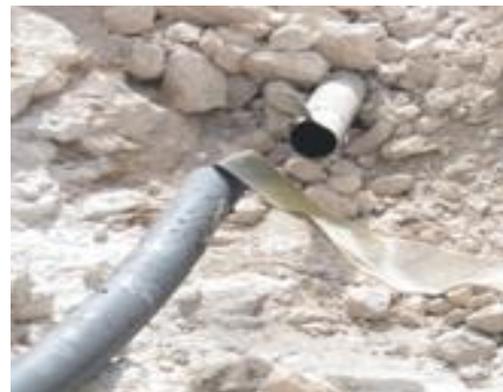
An 8-inch pipeline, transferring natural gas from well to gas gathering unit, southern Iran, experienced an explosion which was due to SCC. Corrosive environment under the disbonded coating and also stresses from soil around the pipe caused slight cracks into the pipe. Stresses from flowing fluid into the pipe helped development and growth of formed cracks and led to SCC and then explosion as shown in Figure 1.

Figure 1. The failed natural gas pipeline due to SCC

Based on the occurred explosions in the natural gas transmission pipeline, a procedure provided for pipe excavation and external corrosion direct assessment. Such measures are taken to secure the safety of personnel and production. A distance of 200 meter from both wellhead sites and gas gathering units were excavated. The results of investigation and comparison with standards like ASME B31.8 and ASME B31G 2009 are shown below. After ECDA and then sand blasting, tape wrapping was performed with inner layer, 3ply PE CO extrude, and outer layer with 50% overlapping. Next, after Holiday Detector Testing, pipe backfilling was performed according to NACE RP0188. In order to avoid disbonding

phenomenon, according to NACE standards, 100 mv polarization shift criterion was regulated.
