Settlement Monitoring of Embankment Dams: Case Study of Gurara Dam, North Central Nigeria

Osuagwu J. C.¹, Owakah A.², Chukwuocha A. C.³, Ibeje A. O.⁴

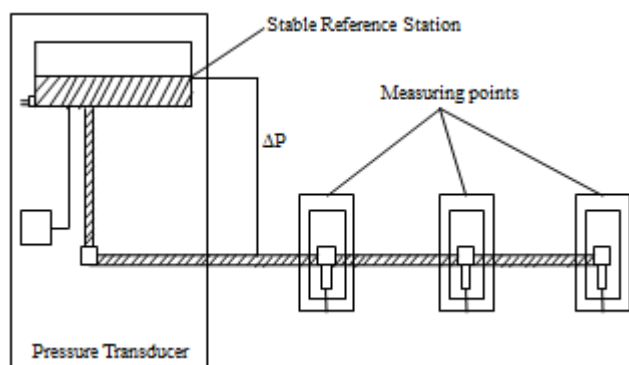
Figure 2. DSM system

Figure 1 shows a typical DSM system setup at a section of the dam; this system consists of three gauging points and one reference point. Similar systems are setup at other sections of the dam to record the embankment settlement using a device which measures and monitors vertical displacement of the dam. The system is based on the principle of communicating vessels where each level gauge represents measuring point. Any vertical movement of the measurement point causes fluid redistribution in the circuit and thus level variation inside each gauge. The change in fluid level in each gauge corresponds to change in displacement. The signals are processed to obtain the differential displacement between the settlement gauge and the reference gauge. This is measured electrically by the sensor using a readout device.
