Flood Containment System for Vilarinho Avenue Region: Detention Basin

Beatriz de Abreu Guedes¹, Letícia da Silva Assunção², Juliano de Freitas Dutra³, Renata Leal Henriques⁴

Keywords- Detetion Basin, Floods, Vilarinho Avenue

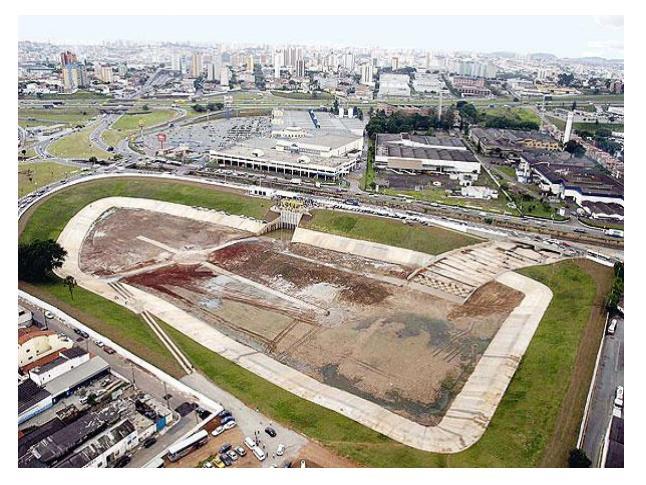
Figure 1. Detention basin of Vila Paulicea, São Paulo.

They can be opened or closed. The open ones, Fig.1, have smaller capacity when compared to the closed ones, but they have simple implantation and are easy to keep. They can integrate with the urban landscape and due to this, they have a rigid maintenance plan, because the population can get in touch with them. The close ones are difficult to maintain, may have large volumes, they are more complex to deployed, so they are more expensive. They do not integrate with the urban landscape, thus the maintenance time is bigger because they do not get in touch with the population. It is important to emphasize that the detention basin can be dangerous if it is not properly projected, implanted and held.

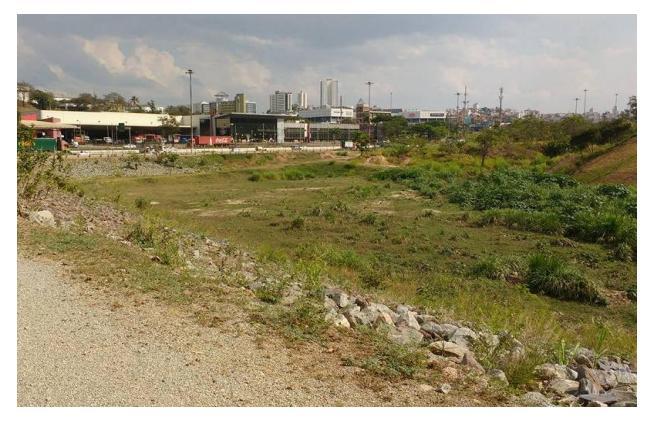
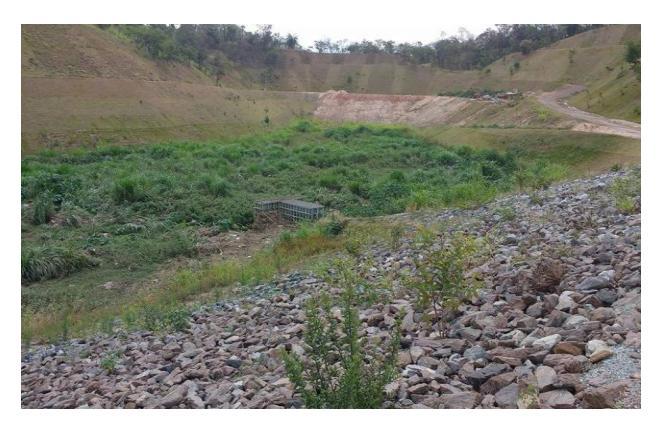
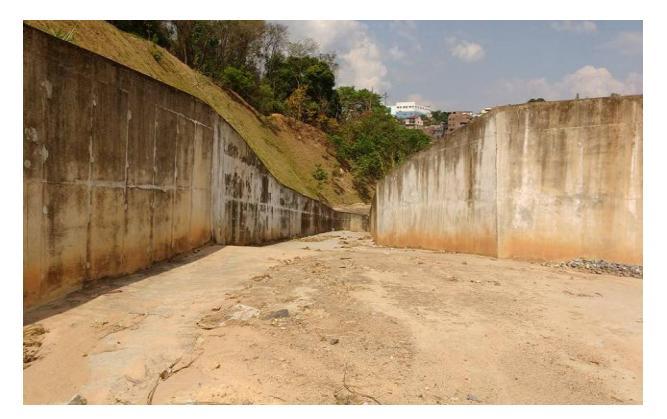
Figure 2. Detention basin of Córrego Engenho Nogueira.

Figure 3. Detention basin of Córrego Engenho Nogueira.

Figure 4. Detention basin of Córrego Engenho Nogueira.

The searches, in order to deepen the research, visited the detention basin of Córrego Engenho Nogueira, in the region of Pampulha, Fig.2, Fig.3, Fig.4, where they were assisted by Sudecap engineer responsible for the place. It supports a volume of 110,000m³ and was developed to minimize the effects of flooding at the Federal University of Minas Gerais and Pampulha Airport.

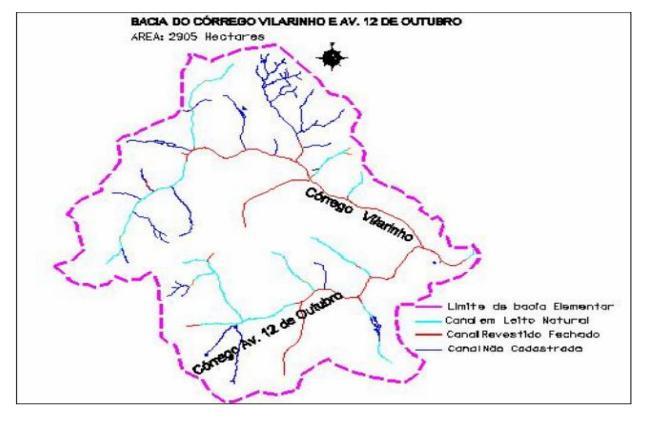
Figure 6. Vilarinho sub basin.

In October of 2015 there was a great flood in one of the sub basins of the city: the Vilarinho sub basin, Fig.6, whose flood dragged cars and destroyed many trades. Reference [2], the City Hall of Belo Horizonte explained that the Hydrological Monitoring System of the County registered 57mm of rain in and most of them occurred in a period of 30 minutes, which increase the chances of flood.

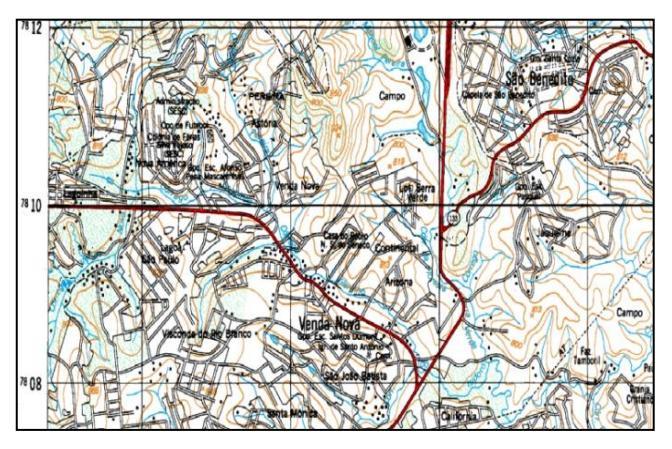
Fig. 7 presents a part of the topographic map of Belo Horizonte with focus on the region of Vilarinho. It has the contour lines and streams that pass through the region, among them the Vilarinho stream, which was channeled.

Figure 7. Topographic map of Belo Horizonte.

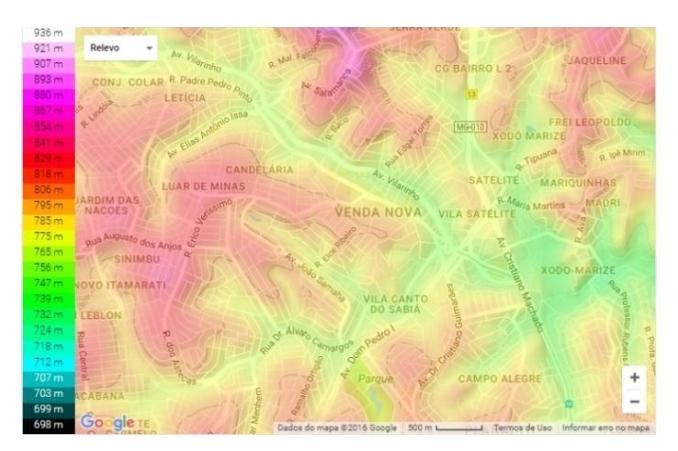
When the region is analyzed more specifically, it is possible to see that the area which suffers more with the floods is located in lower altitudes, Fig. 8.

Figure 8. Topographic map of Belo Horizonte.

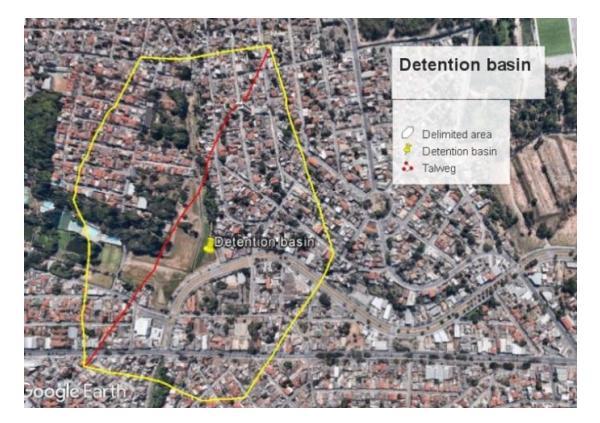
With satellites images obtained in the software of Google Earth, it was possible to demarcate the coverage area of the detention basin, Fig.9.

Figure 9. Delimited area.

After the demarcation, the data below were extracted:

A = area = 0,52km² = 52ha T = return period = 100years L= talweg length = 0,98km H= difference in quotas = 6m I= declivity = 11%

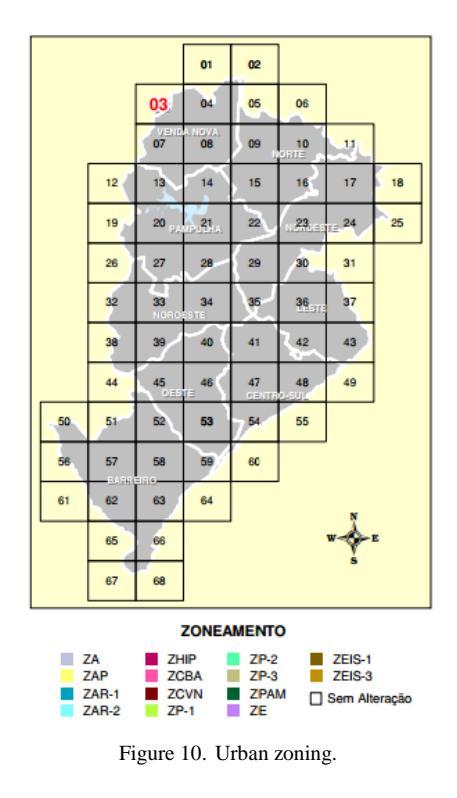
C = runoff coefficient; which, according to [13], can be obtained through the Tab. 3, with values of the volumetric coefficient (C2), as a function of urban zoning [1], identified by the mapping shown in Fig.10.

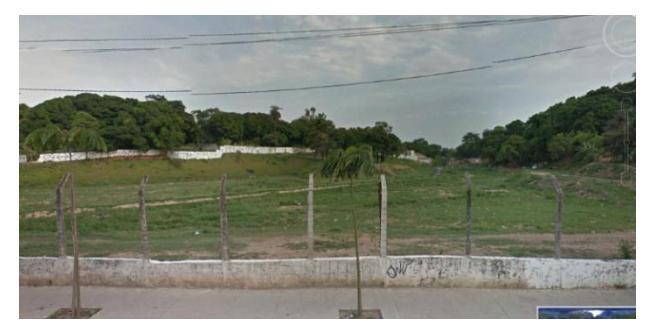
After the local hydrological data were obtained, the group located in the demarcated area, an empty lot on Vilarinho Avenue, which may be the location of the detention basin, 11.

Figure 11. Empty lot for possible contruction.

The basin of detention would have a lowering in relation to the level of the street, to the best use of the flow rate found. In addition, information signs for the population, with guidelines for evasion of the area in case of heavy rains and with the risks of permanence in the area in this situation.

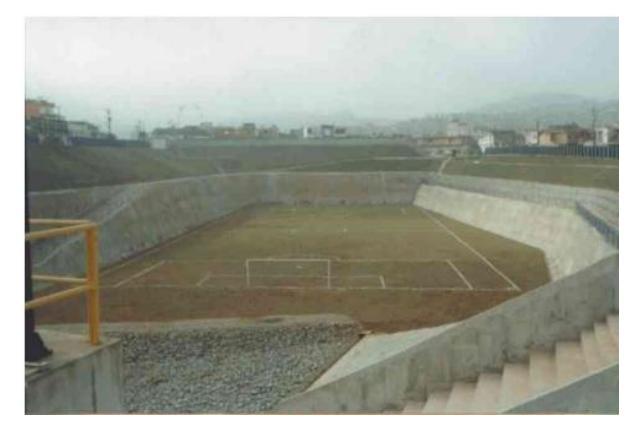
The project would be a detention basin, with leisure area: field, square or an open air gym, as in Fig.12, Fig.13.

Figure 12. Detention basin in São Bernardo do Campo.

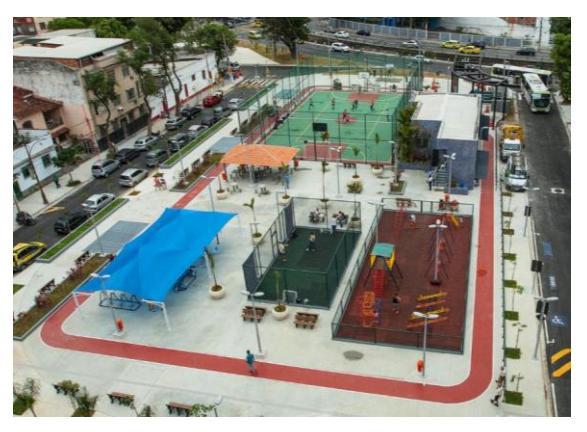
Figure 13. Praça Niterói on a detention basin with capacity for 58 million litters of water.
